# Carbon Neutral Case Study St Paul's Cathedral, London

416 Tonnes of IKO Permaphalt Adds Long-Term Durability to Famous Landmark

**Project Description**

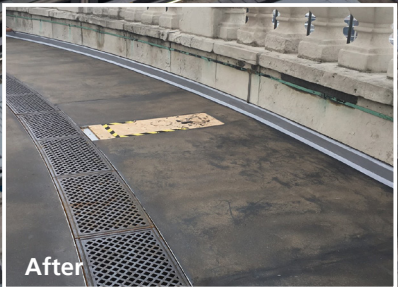
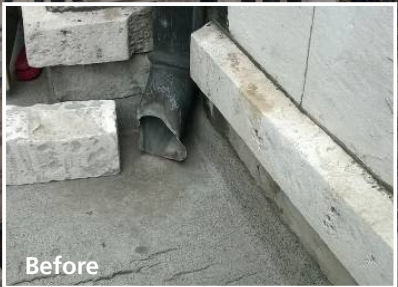
Asphalt was stripped and re-laid in sections to ensure watertightness. Stripping enabled the client to view the condition of the Portland Stone paving beneath the asphalt – this work revealed a disused stairwell that was made safe by operatives.

The Stone Gallery includes a central gutter covered by iron grills that were removed, cleaned and refitted on the new asphalt (122lm). To ensure the correct width of asphalt was applied a gutter template was fabricated and used as a guide by the asphalters, requiring skilled precision work. Other detail asphalt works involved adjustments to rainwater outlets to improve drainage, and vertical upstand into a chase, including a double angle fillet around the Gallery's circumference (286lm).
