## CASE STUDY

# HATTON HALL, WELLINGBOROUGH

## Roof refurbishment for sheltered housing

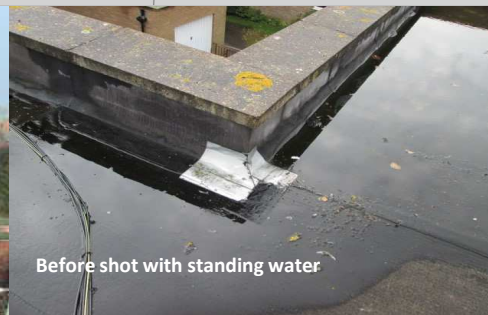
Before shot with standing water

The IKO survey identified that the existing roof drainage falls directed water away from the outlet locations, leading to severe ponding. In addition, one of the main causes of the leaks occurring to the building related to the parapet walls - the parapet concrete coping was allowing some water penetration through the open coping stone joints, so the existing "chase and flashing parapet detail" needed attention. Other leaks related to poor detailing at pipe penetrations.

A new tapered insulation scheme was designed to compensate for the fact that existing falls were directing water away from the drainage outlets. Also the existing "chase and flashing parapet detail" was re-designed to carry the waterproofing up and over the parapet wall, eliminating the leakage which had stained the façade of the building.
