# CHRIST CHURCH PARISH HALL, DOWNEND, BRISTOL

Locals benefit from refurbished roof

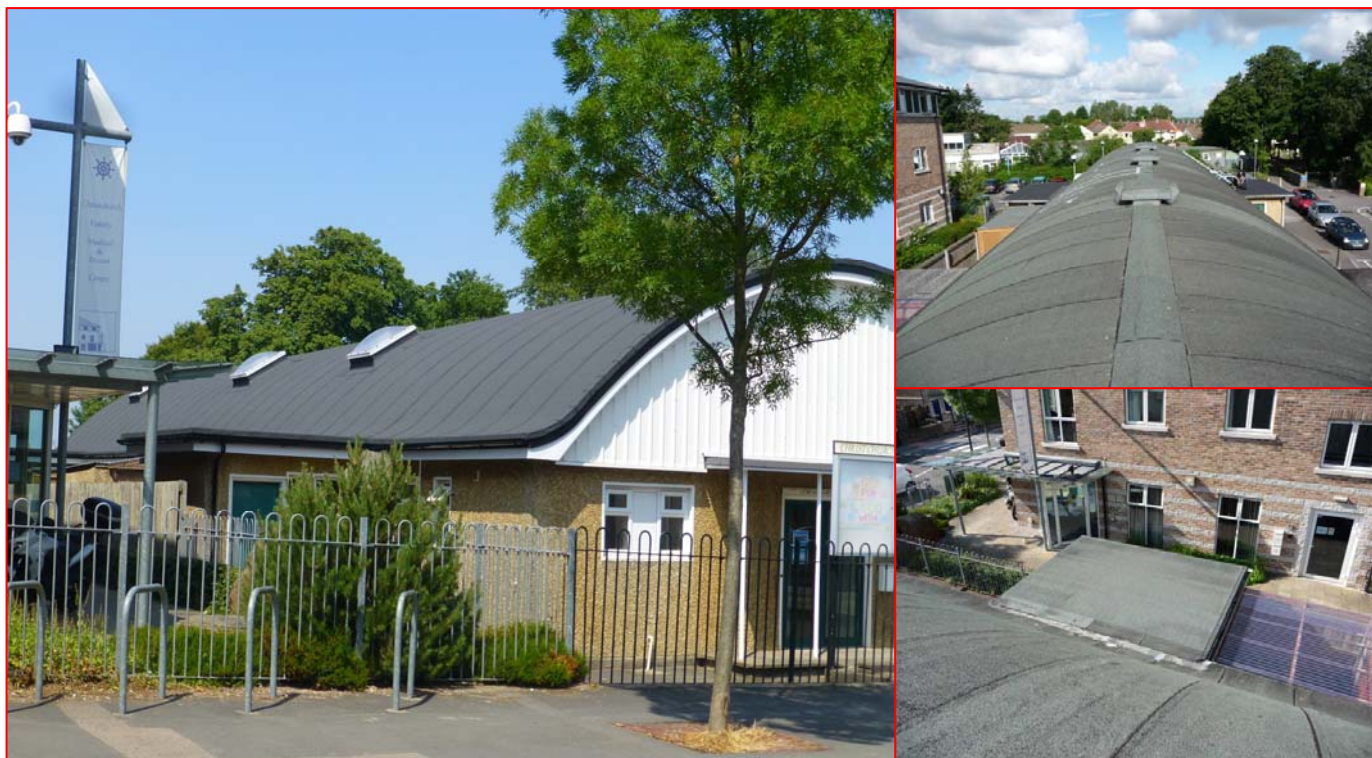
From the inspection carried out, the roofing system was in a poor condition, and had exceeded its serviceable life. The waterproofing membrane had become age hardened and brittle, with evidence of surface cracking, and apparent blistering. Previous 'patch repairs' were no longer suitable to keep the water out.

Natural ageing had played a principle part in the deterioration of the traditional built up roofing system. Progressive weathering away and fracturing of the top protective coating had eventually resulted in the localised exposure of the base fabric beneath.

Some areas of the existing deck were constructed of chipboard. The core sample & moisture probe analysis highlighted that the deck was in a deteriorating condition due to water ingress. The existing deck had lost its structural strength and was classed as fragile. The deck needed to be replaced before the new waterproofing system could be installed.

Davis Roofing removed the existing chipwood decking and waterproofing system reinstating it with a new deck and a high performance IKO elastomeric Guardian Ultra prevENT waterproofing system. This included the upgrade of the insulation to achieve a revised U value 0.18w/mK. IKO Superlite rooflights were installed to allow extra light in to the hall.
