## LAVERSTOCK, BOURNEMOUTH

Liquid waterproofing solution meets refurbishment needs of coastal residential development

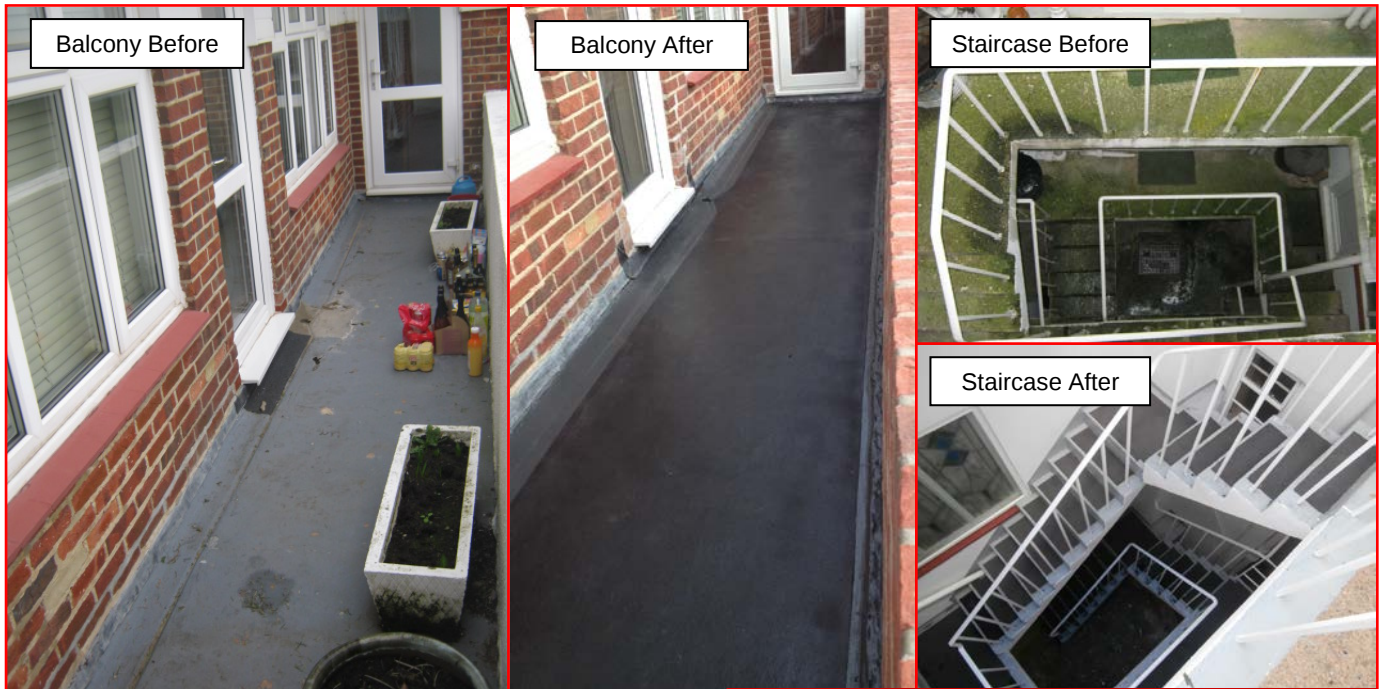
Laverstock is a residential block of flats and situated on the cliff tops overlooking the sea at Boscombe, Bournemouth. The concrete components of the staircases, which provide residents with access to the flats on the upper levels, had not been waterproofed when initially constructed in the 1930's. The concrete had therefore become eroded over time due to general wear and tear and by the continued exposure to the coastal elements. Large sections of the concrete had also blown due to the continual freeze-thaw cycle of the winter months.

The existing concrete needed to be repaired where the elements had already taken their toll. Once complete, the IKO approved contractor C&D Roofing & Leadwork, cleaned the concrete and applied the IKO Polimar FCS primer to the surface and metal balustrades. Once cured, the IKO Polimar FCS liquid system was installed to the substrate and reinforced at abutments. Contrasting aggregated sections were laid where regular foot traffic will occur.
