# Broadway Plaza, Birmingham

6,000m<sup>2</sup> Enhanced Pedestrian Spaces and Car Park Waterproofing Solution

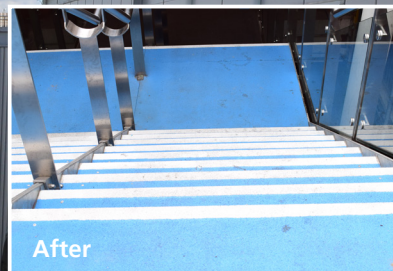
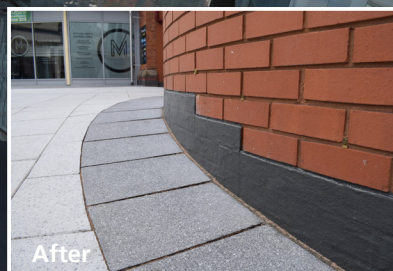
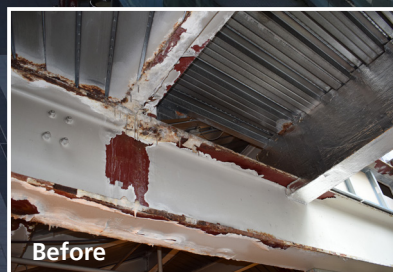
The Plaza had suffered severe water ingress through the main deck. IKO's appraisal highlighted the poor condition of the existing waterproofing system to the main plaza, walkways, balconies and car park.

Water ingress had caused fire retardant paint to peel from the metal structure in the car park, some rust to the metal structure and adhoc guttering had been added to divert water from within some of the accommodation blocks. Insufficient drainage was noted during large downpours and corrosion was visible to door thresholds of some of the outlets.

From exposing areas IKO found that the original waterproofing system and existing concrete screed to be saturated with no seal protecting the buildings or original sheet system sealed to the perimeter laps. Inconsistent levels meant that the Plaza would also suffer from standing water.

The existing waterproofing system was stripped to the concrete substrate and new drainage channels were introduced with falls directing water to the new high level drainage. IKO Permascreed was introduced to reduce the risk of gassing from the saturated screed. IKO Polimar FCS (Fast Curing System) Waterproofing System was introduced across the plaza terminating to brickwork, stanchions, lights and door thresholds. Exposed areas were treated with IKO FCS Balcony and Walkway System preserving the system while taking foot traffic. IKO Polimar FCS provided a feature on these details as well as a practical solution where construction provided a challenge.

The upper level of the car park's cracks and fistulas were treated to elevate further degrading. IKO Polimar Fillers and Levelling Mortar were

installed to take deflections from the surface. IKO Polimar FCS Walkway System was then applied.

Escalators were removed and staircases installed with an IKO Polimar FCS finish. Damaged kerbs, gutters, expansion joints or deck/substrate's were correctly fixed to ensure satisfactory installation of the new waterproofing system.

A number of trees required removing as roots were penetrating the waterproofing as a protective layer was never installed. This area was waterproofed with IKO Polimar FCS, backfilled using IKO enertherm XPS insulation board to raise the areas to the desired level followed by a geotextile membrane, coarse and fine aggregate, completed with the final paving.
