# Market Harborough, Leicestershire

## Manhole Reinstatement

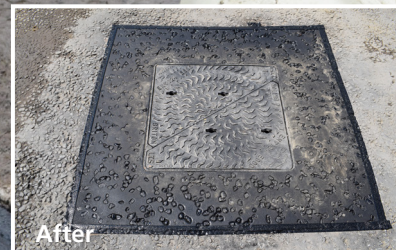
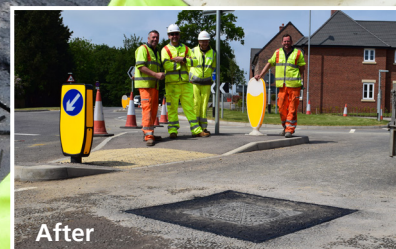
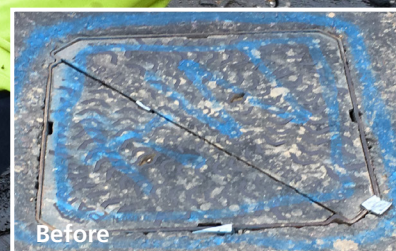
The ongoing loud clanking noise produced by the cars driving over the manhole was deeply frustrating for the local residents, while the sunken manhole was causing damage to cars as well as representing a safety risk to pedestrians and bikes.

Manly Co Ltd a professional ironwork and civil engineering contractor selected IKO Pacopatch to reinstate the failed manhole installation.

IKO Pacopatch is a long-lasting mastic asphalt system, designed to reinstate failing surfaces surrounding manholes, drainage gullies and other public utilities ironworks.

IKO Pacopatch is a two part system comprising of IKO Pacopatch Grout and IKO Pacopatch Bricks. The brick are manufactured with a high percentage of recycled material and forms the bulk of the system providing dimensional stability and aids the cooling of the grout.

The IKO Pacopatch Bricks can be broken as necessary depending on the shape and size of the reinstatement.

IKO Pacopatch Grout is a polymer modified mastic asphalt utilised as the in-fill material. The molten material flows around the IKO Pacopatch Bricks to create an impervious and voidless reinstatement system.
